Test Report

Hygrothermal Performance of Two Facade Systems Incorporating Brickspan Sheets to ETAG 004:2013

Lucideon Reference:	151845 (QT36289/1/SL)/Ref. 1	
Project Title:	Hygrothermal Report of Two Facade Systems Incorporating BRICKSPAN Sheets to ETAG 004:2013	
Client:	Paul James Bishop IP Holdings Ltd Bradley Hill Farmhouse Bradley Hill near Blakeney Gloucestershire GL15 4AW	
For the Attention of:	Mr Paul Bishop	
Author(s):	Miss Veronica De Zuani	
Report Date:	20 August, 2015	
Purchase Order No.:	001 TBS	
Work Location:	Lucideon UK

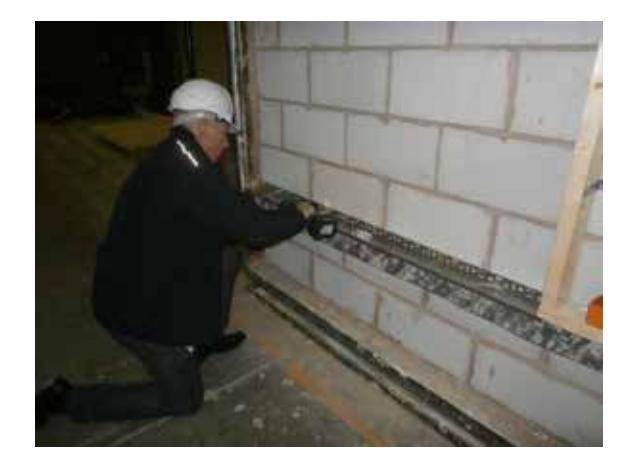
Plate 1 – Attaching the Base Track to the Wall

A base track was installed at the foot of the left hand side of the wall above the second course of blockwork with fixings at nominally 300 mm centres. The base coat was mixed with water (Rate: 25 Kg of MAPEI AR1 GG with 5-6 Lt of water) using a paddle mixer for nominally 3 minutes and allowed to stand for 5 minutes before remixing to a smooth consistency.

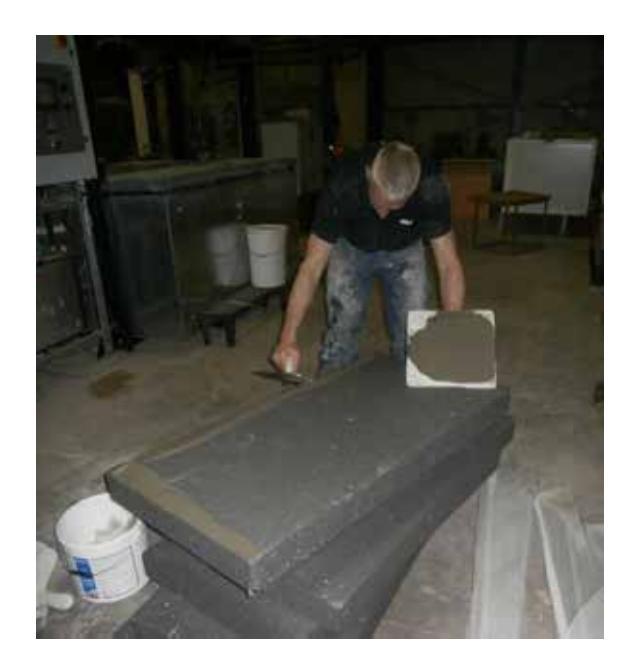
Plate 2 – Applying the Adhesive to the Insulation Slab

The adhesive was trowel applied to the insulation slabs before adhesively fixing the insulation boards to the substrate.

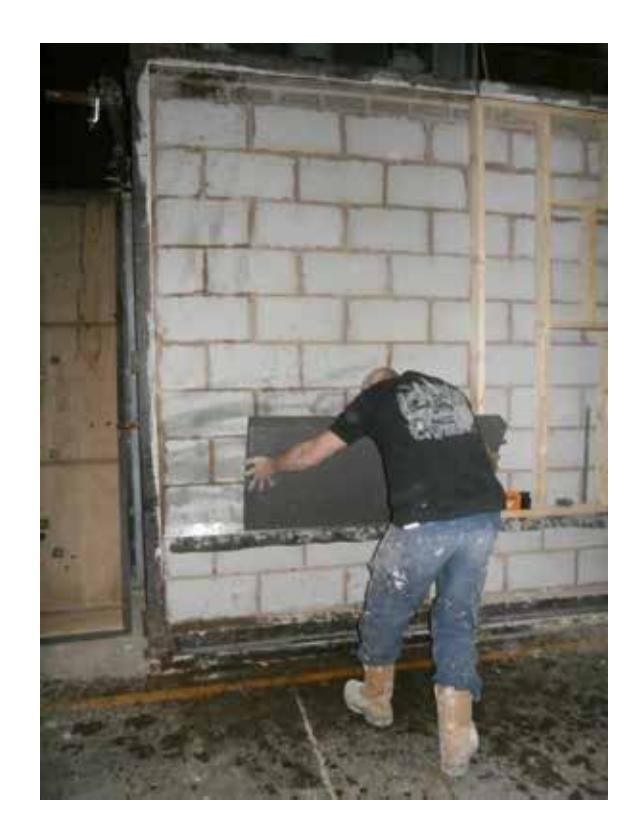
Plate 3 – Adhesively Attaching the Insulation Slab to the Left Hand Side of the Wall

The insulation slabs were positioned horizontally (stack bond) and vertically staggered in a stretcher bond pattern.

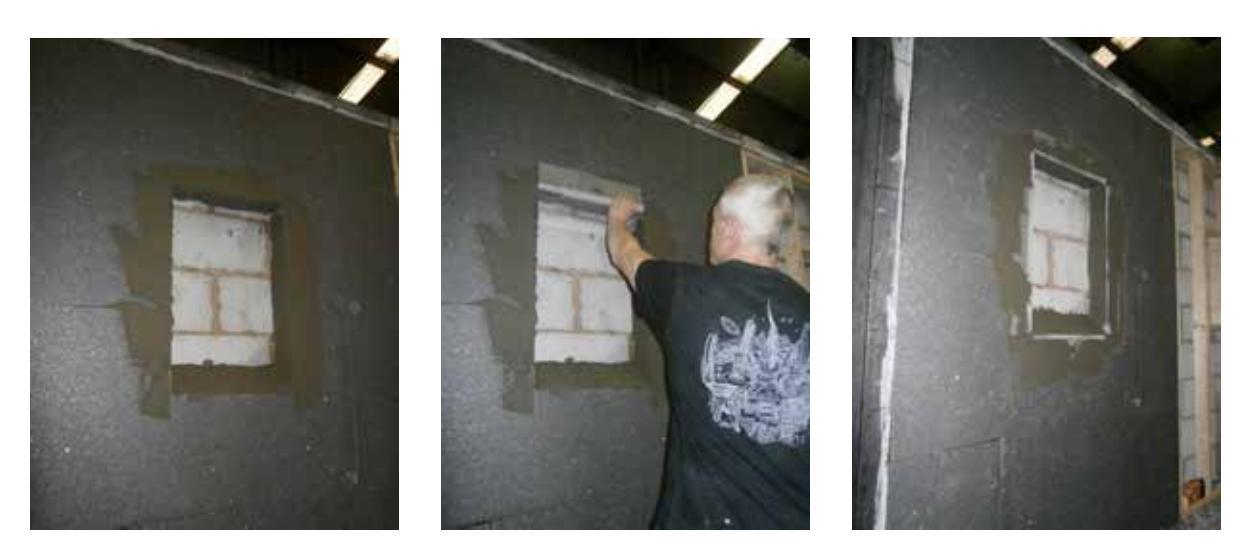
Plate 4 – Application of the Base Coat Around the Window Opening (Left); Applying of the Beading with Mesh Incorporated over the Base Coat (Centre); Flanges Embedded into the Base Coat (Right)

The base coat was applied around the window opening. The corner beadings with mesh incorporated were then applied over the base coat and the mesh were embedded into the coat.

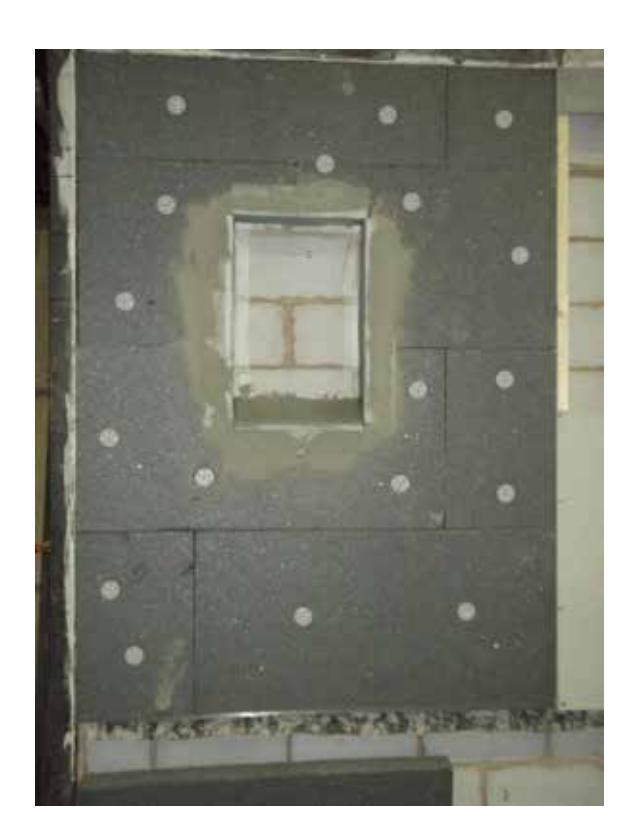
Plate 5 – Insulation Adhesively and Mechanically Fixed to the Wall

The insulation boards were then mechanically fixed with SPIT fixings to the face of the masonry substrate.

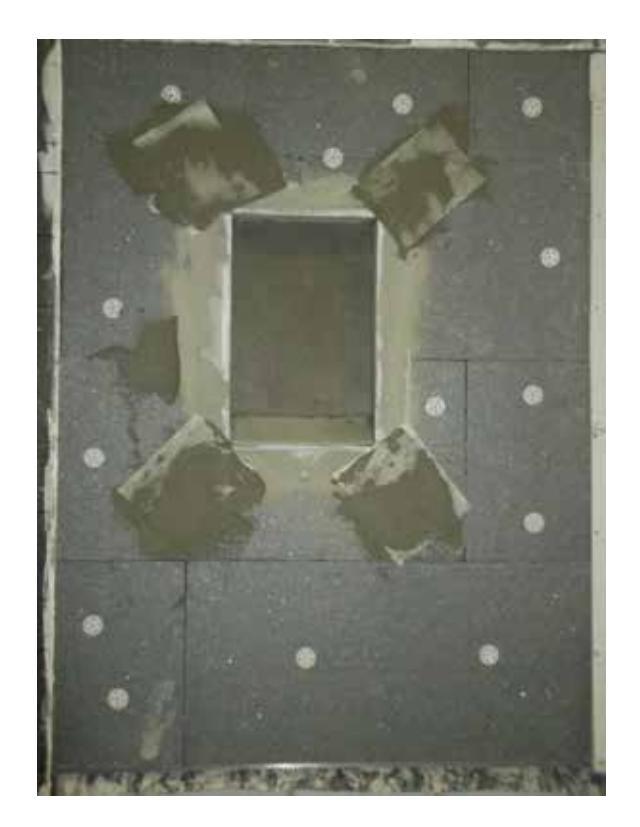
Plate 6 – Stress Patches Applied Around Window Opening

The base coat was applied on the external corners of the opening before fitting the mesh (cut into $300 \times 300 \text{ mm}$ squares) around the window, setting it at an angle of 45 degrees and embedding into the coat.

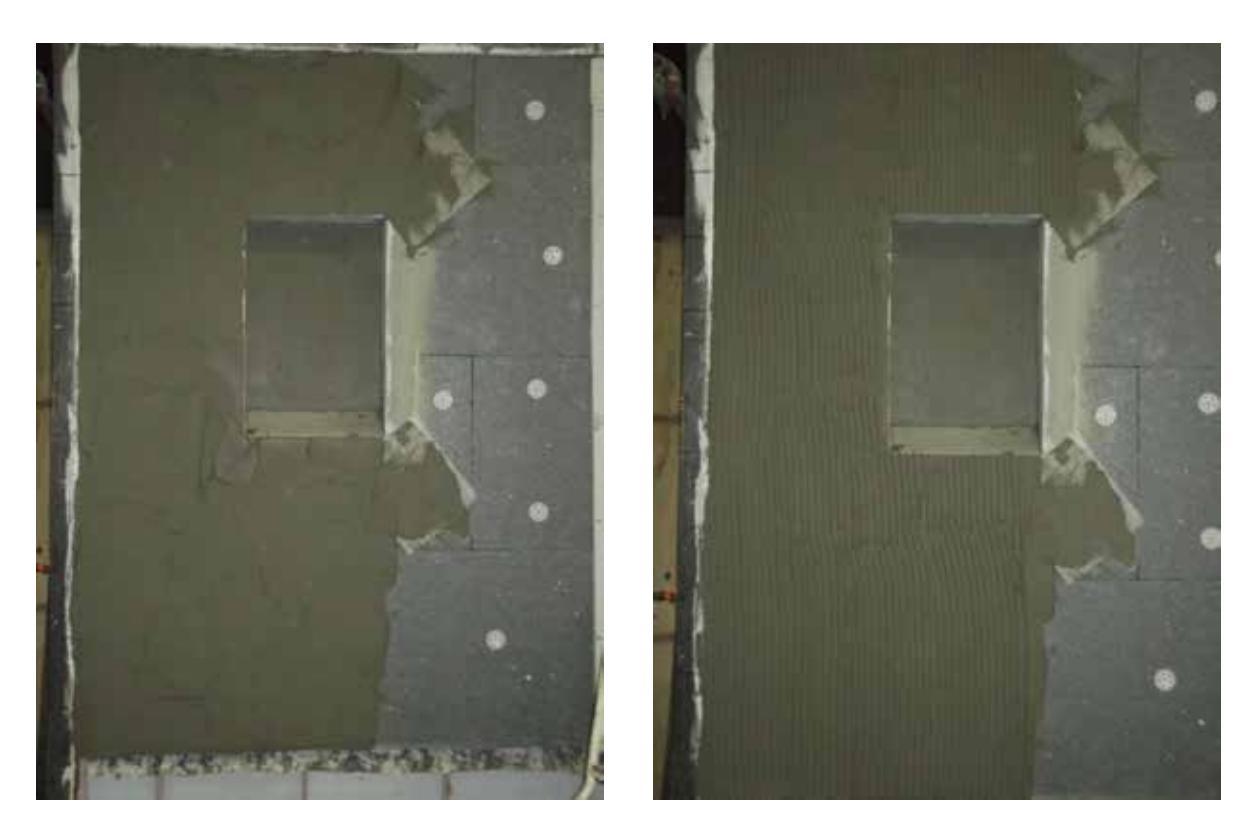
Plate 7 – Base Coat Applied over the Insulation (Left) and Base Coat Streaked with a Notched Trowel (Right)

The base coat was trowel applied to the left hand side of the wall. A notched trowel was used to streak the base coat.

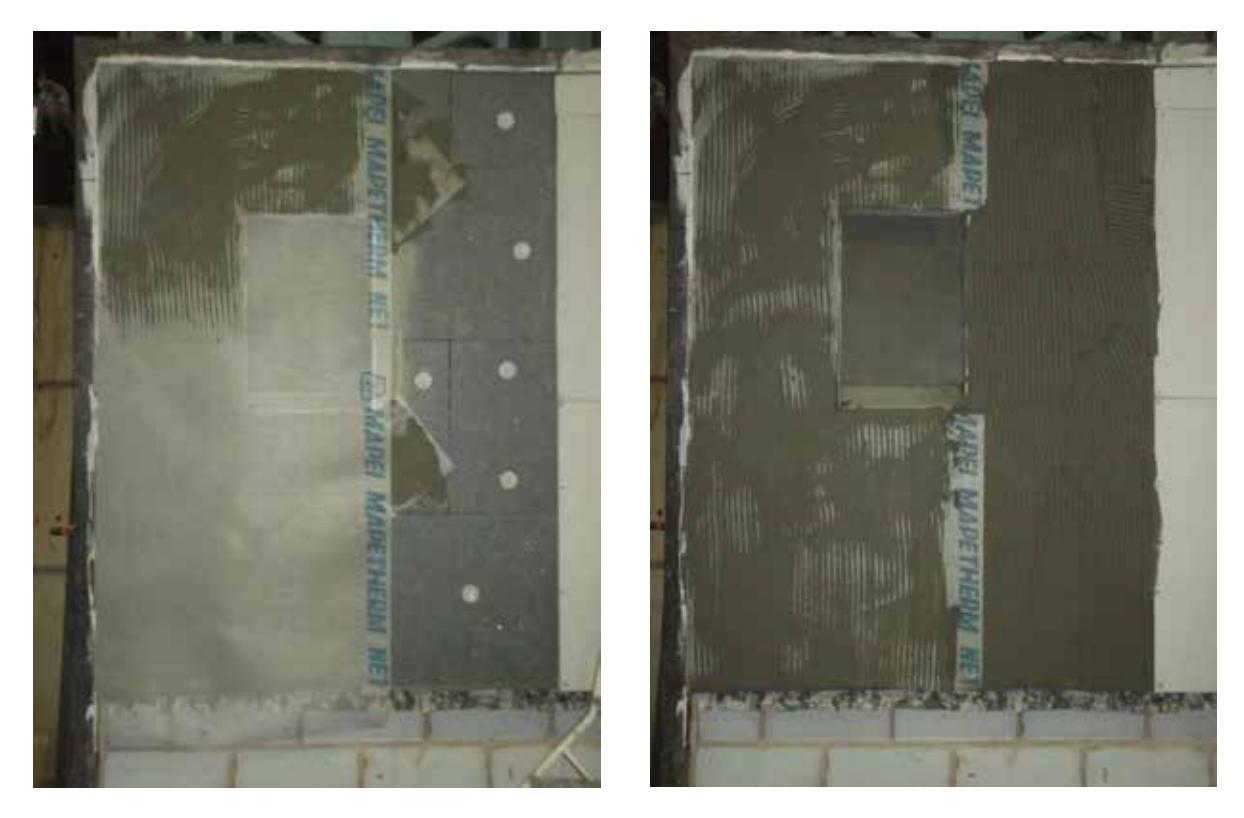
Plate 8 – Mesh Applied over the Base Coat (Left) and Mesh Embedded into the Base Coat (Right)

The mesh was applied (overlap of 100 mm) and embedded into the base coat.

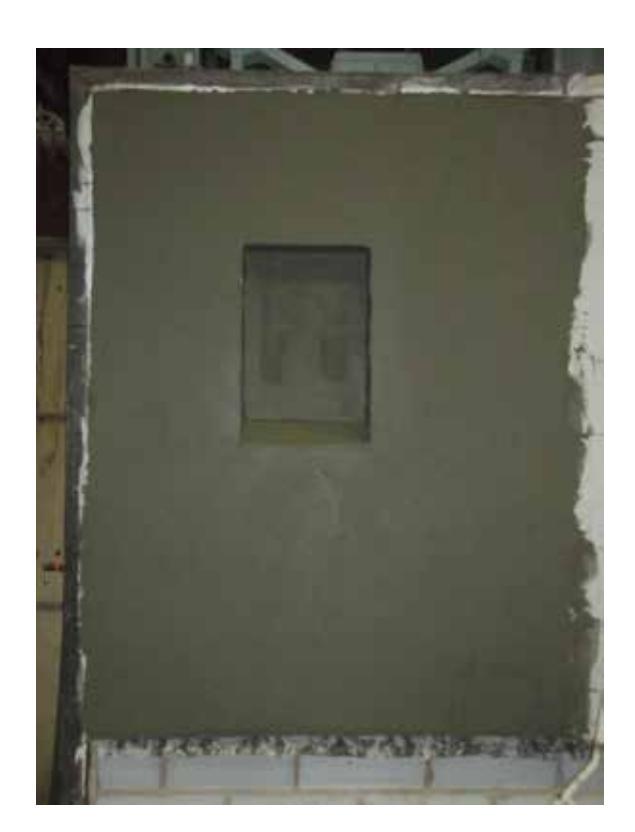
Plate 9 – Additional Layer of Base Coat Applied to the Left Hand Side of the Wall

The technical team trowel applied an additional layer of base coat, which was then levelled with a wide levelling trowel.

The base coat was applied to a total thickness of 5 mm and it was allowed to dry for two days.

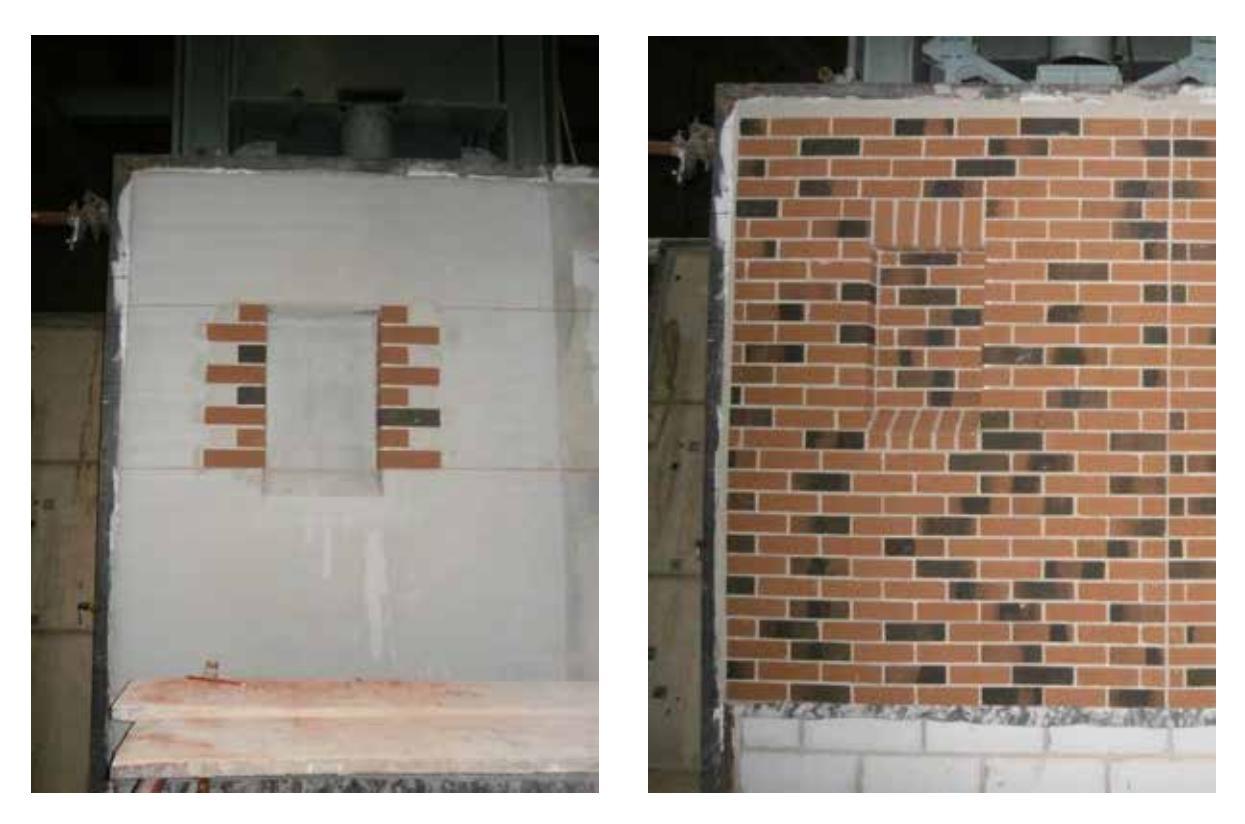
Plate 10 – Brickspan Corner Sheet Adhesively Applied Around the Window Opening (Left) and Briskspan Sheet Fully Applied to the Left Hand Side of the Wall (Right)

The Brickspan sheets were then adhesively applied over the base coat using the MAPEI Fix & Grout Brick Adhesive.

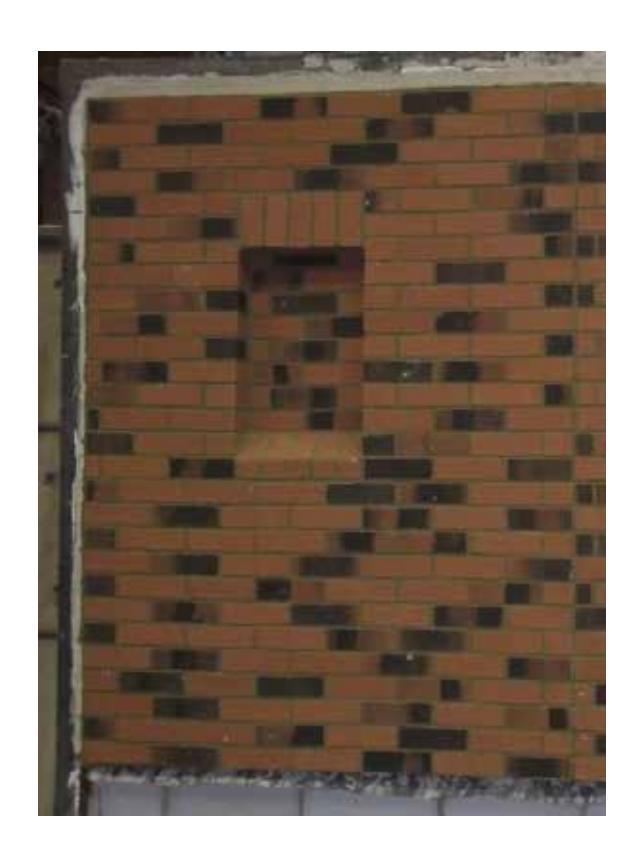
Plate 11 – Brickspan Sheets Pointed with Pointing Mortar

After one day the bricks were pointed with the Brickspan pointing mortar.

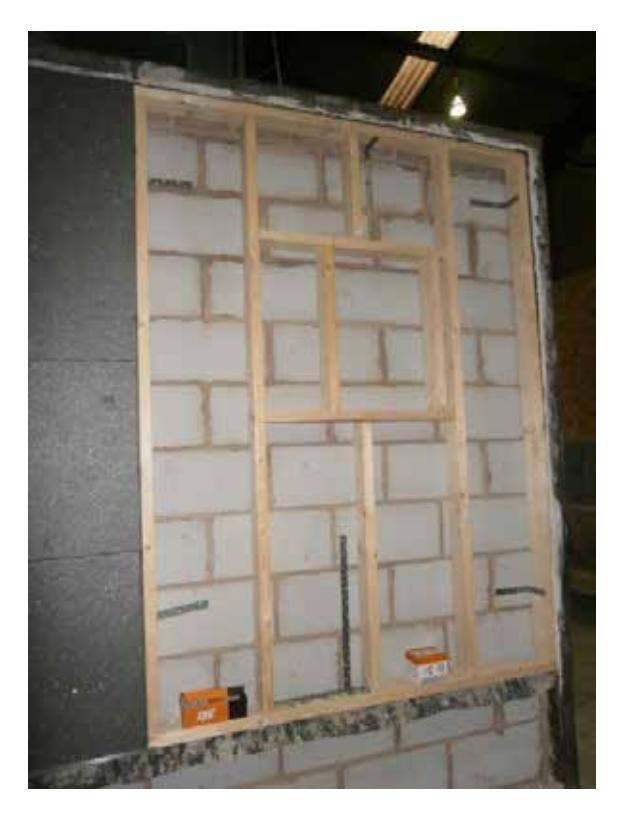
Plate 12 – Timber Frame Installed

A timber system was installed on the right hand side of the wall over the masonry substrate with studs at nominally 600 mm centres.

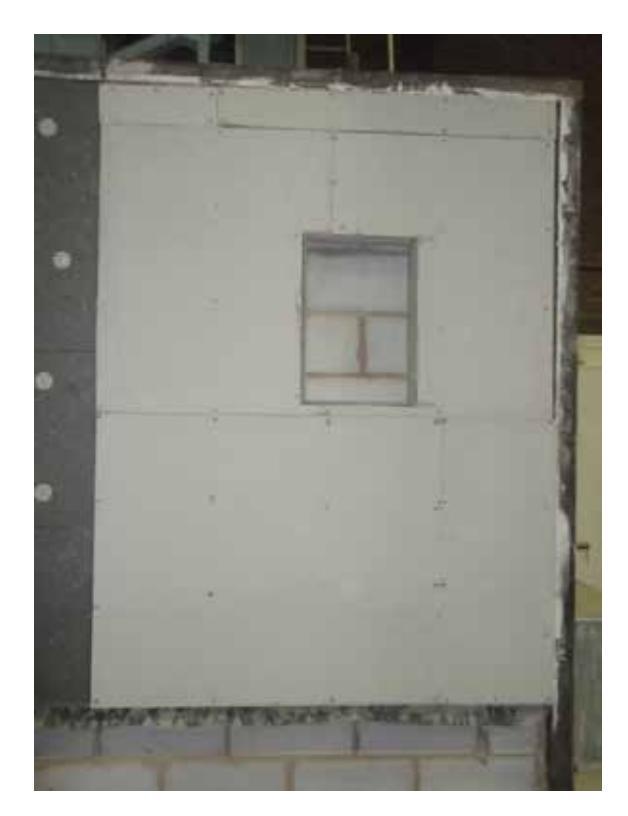
Plate 13 – Cement Board Fixed to the Timber Frame

The FERMACELL Powerpanel H₂O cement boards were fixed into the framed system.

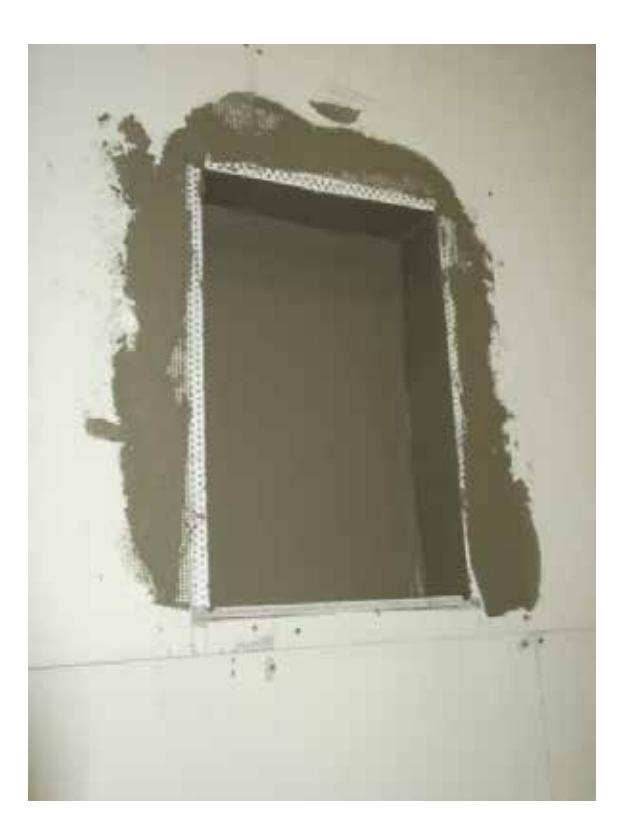
Plate 14 – Beading with Mesh Incorporated Applied Around the Window Opening

The base coat was applied around the window opening. The corner beadings with mesh incorporated were then applied over the MAPEI AR1 GG and the mesh were embedded into the coat.

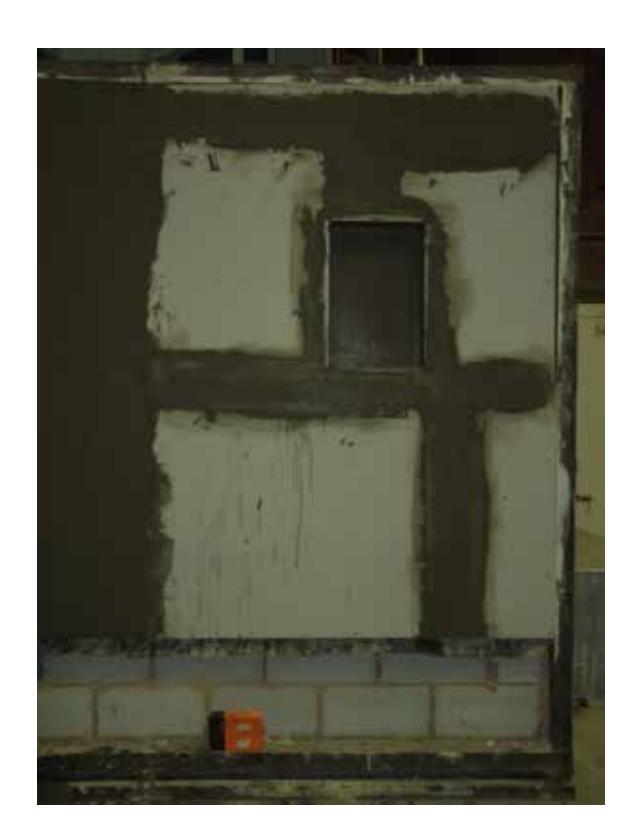
Plate 15 – Base Coat and Mesh Applied over Cement Board Joints

The MAPEI AR1 GG was applied over the cement board joints before embedding the mesh into the coat.

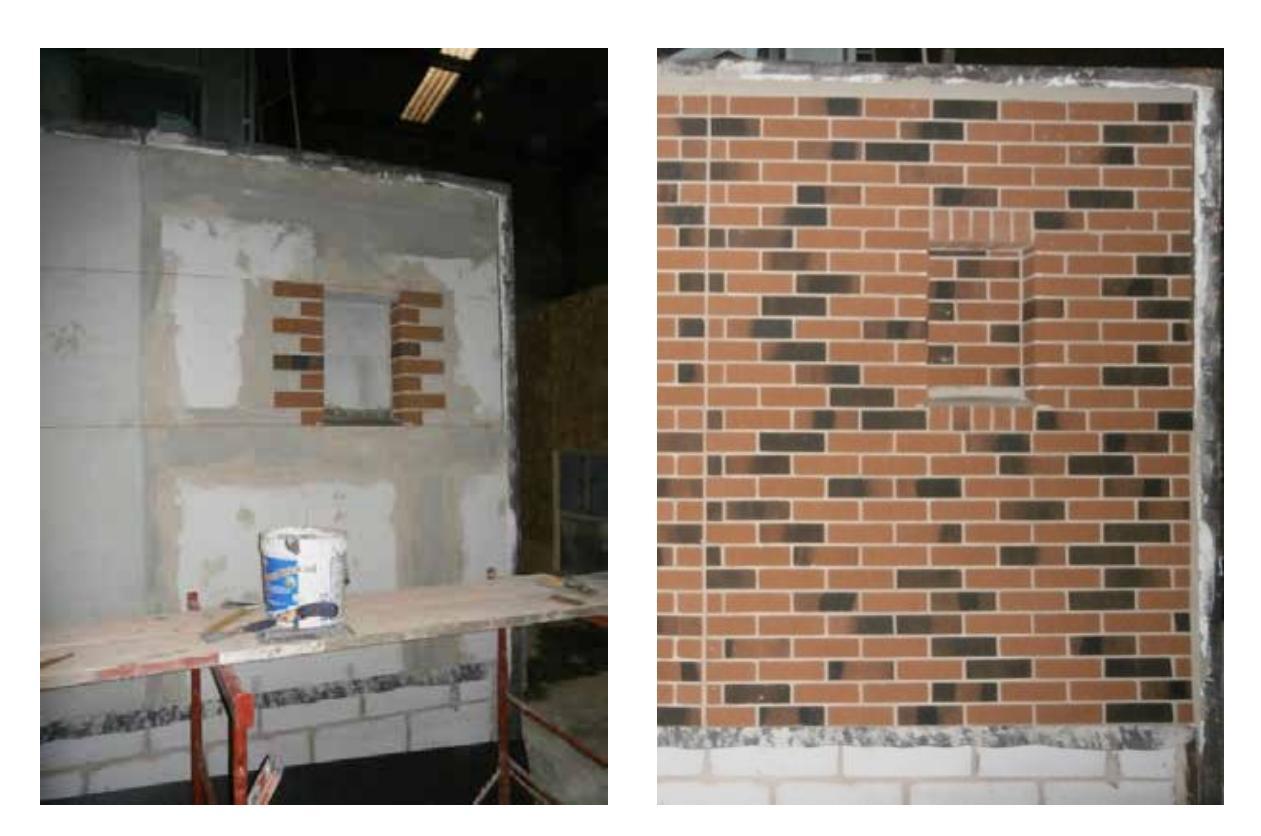
Plate 16 – Brickspan Corner Sheet Adhesively Applied Around the Window Opening (Left) and Briskspan Sheet Fully Applied to the Right Hand Side of the Wall (Right)

The wall was allowed to cure for two days before adhesively applying on the right hand side of the wall the Brickspan sheets using the MAPEI Fix & Grout Brick Adhesive.

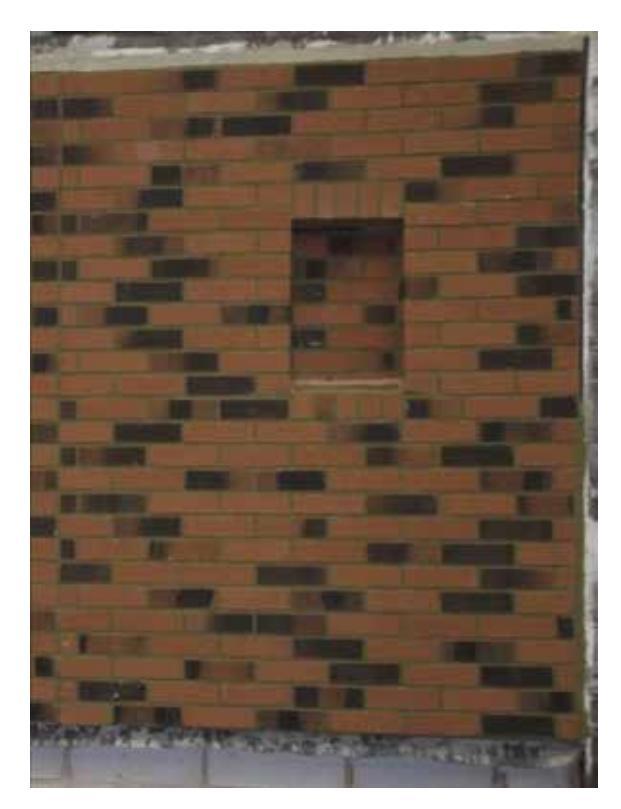
Plate 17 – Brickspan Sheets Pointed with Pointing Mortar

After one day the bricks were pointed with the Brickspan pointing mortar.

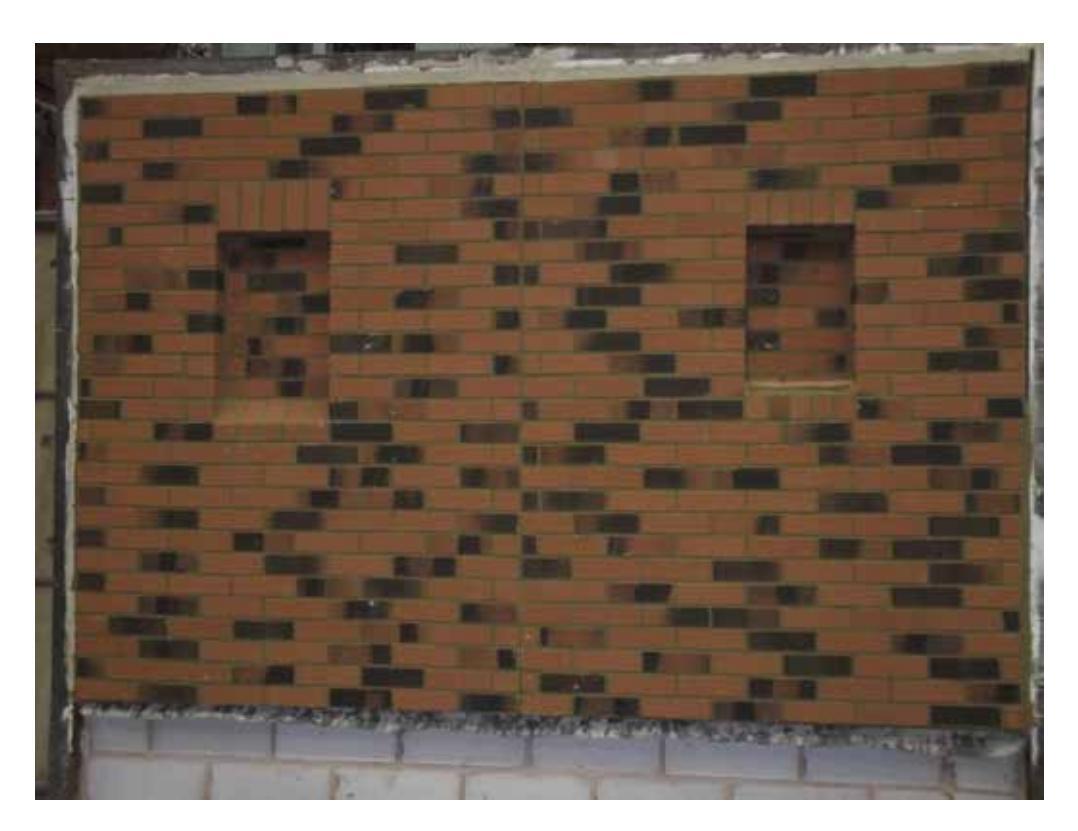
Plate 18 –View of the Wall at the End of the Installation

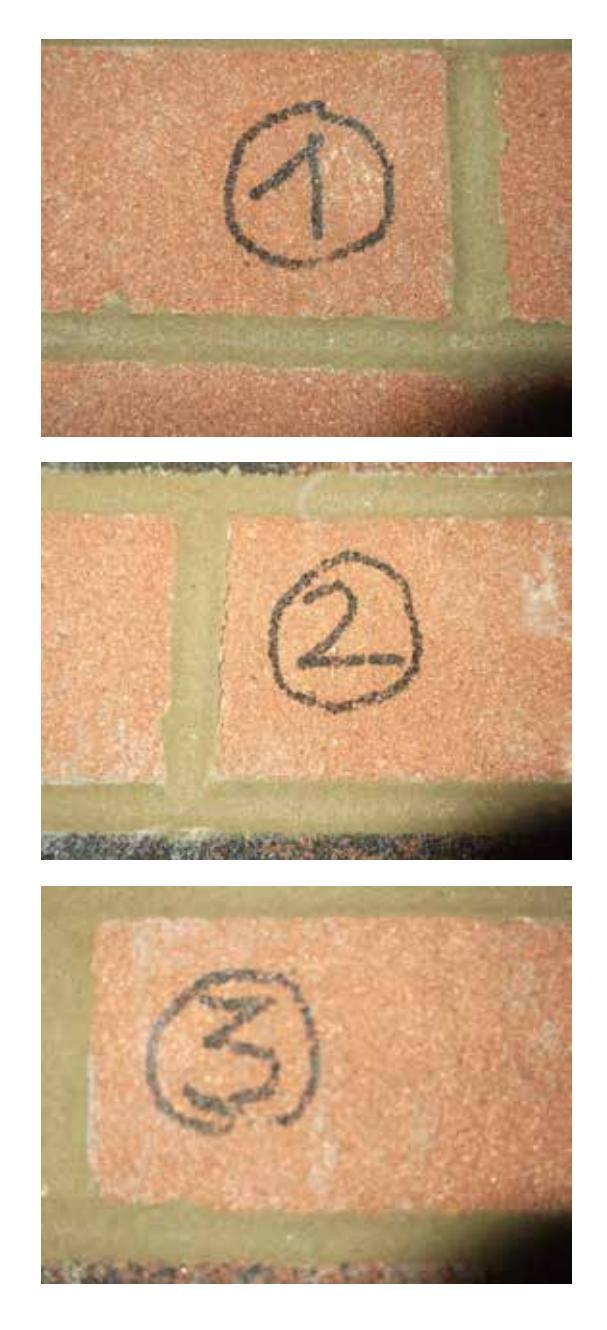
Location	Diameter Under 3 Joules Impact Energy (mm)	Cracking	Diameter Under 10 Joules Impact Energy (mm)	Cracking
1	-	No Damage	-	Slight Indentation
2	-	No Damage	-	Indentation with slight cracking around the perimeter of the brickslip in the pointing mortar
3	-	No Damage	-	Slight Indentation

The wall was laid down in the structures laboratory. A 1 Kg steel ball was allowed to impact the face of the panel at a height of 1020 mm to give an impact energy of 10 joules. A 0.5 Kg ball was allowed to impact the face of the panel from a height of 610 mm to give an impact energy of 3 joules respectively. Care was taken during the test not to allow the ball to impact the same spot more than once.

Test positions were chosen as to be the most onerous and representing the two finishes. On completion of each impact using digital callipers, the diameter of the impact area was measured and recorded. The presence of any micro-cracks, cracks at the impact point and at the circumference was noted.

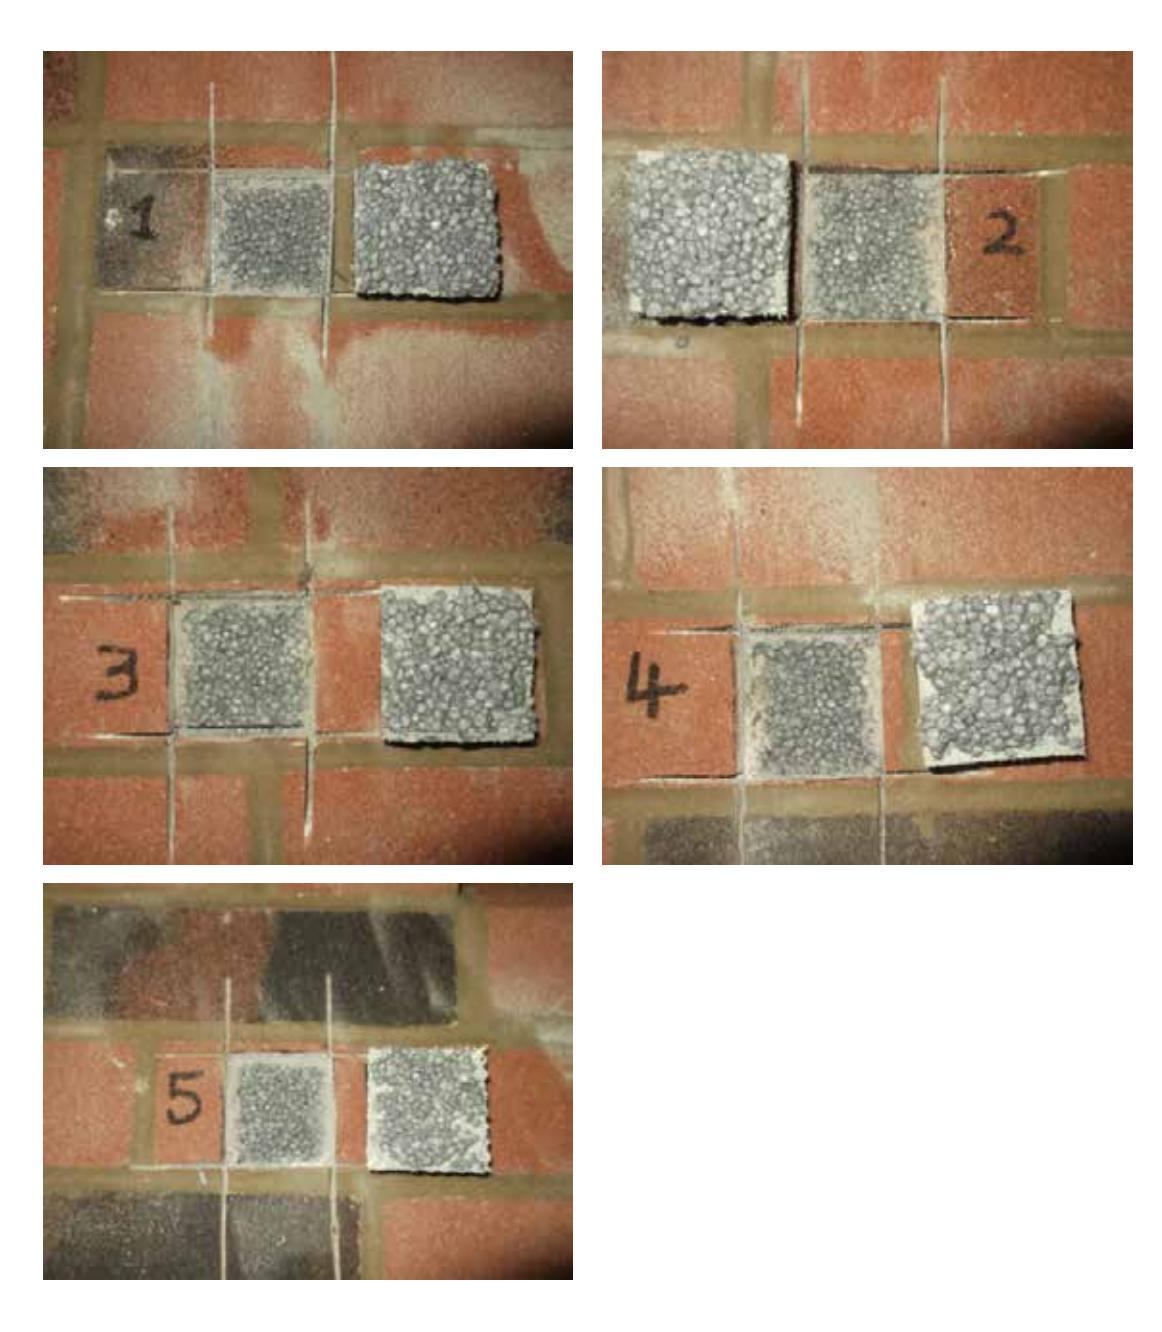
Location	Pull-Off Strength (N/mm ²)	Mode of Failure
1	0.15	Failure within insulation Body
2	0.07	Failure within insulation Body
3	0.09	Failure within insulation Body
4	0.19	Failure within insulation Body
5	0.06	Failure within insulation Body
Mean	0.11	-

Plates 2 - Bond Strength After Hygrothermal Test – System One

Five No. 50 mm squares for each system were cut through the base coat and the insulation (System One) and through the cement board (System Two). A steel plate was bonded to the area with an epoxy resin and allowed to cure for 24 hours. A centralised tensile load was provided to the plate at a rate of 1 to 10 mm/minute through a studded bar attached to a hydraulic ram and load cell arrangement.

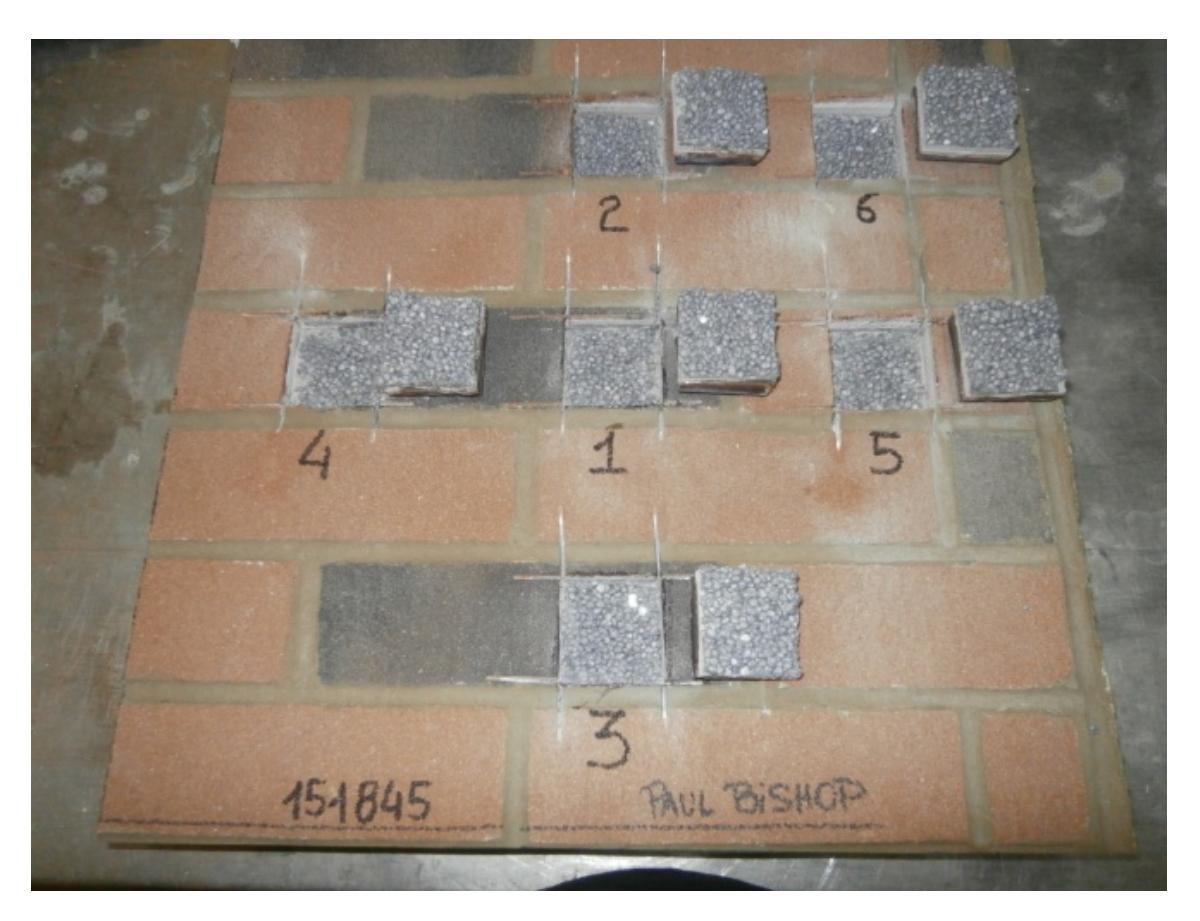
Location	Pull-Off Strength (N/mm ²)	Mode of Failure
1	0.11	Failure within insulation body
2	0.11	Failure within insulation body
3	0.11	Failure within insulation body
4	0.11	Failure within insulation body
5	0.11	Failure within insulation body
Mean	0.11	-

Plates 3 - Bond Strength Control - System One

Five No. 50 mm squares for each system were cut through the base coat and the insulation (System One) and through the cement board (System Two) to a nominal depth of 10 mm. A steel plate was bonded to the area with an epoxy resin and allowed to cure for 24 hours. A centralised tensile load was provided to the plate at a rate of 1 to 10 mm/minute through an Instron tensile load machine.

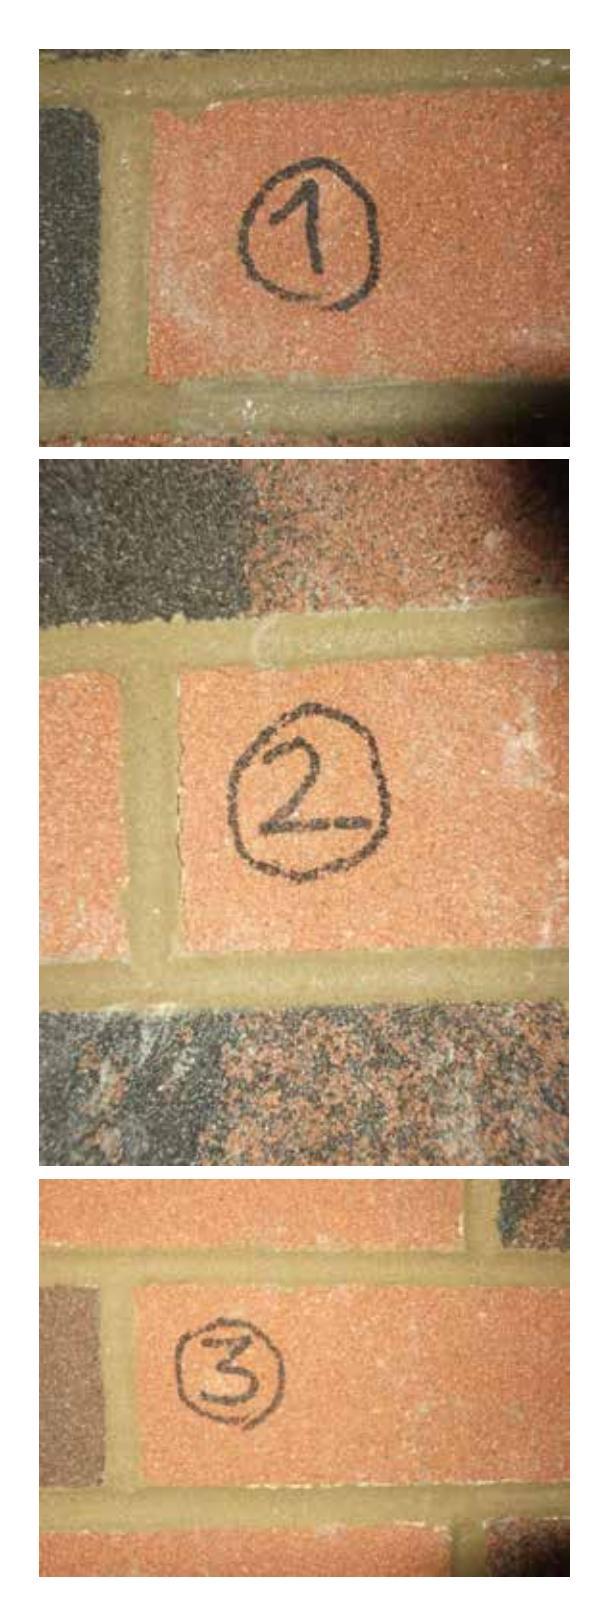
Location	Diameter Under 3 Joules Impact Energy (mm)	Cracking	Diameter Under 10 Joules Impact Energy (mm)	Cracking
1	-	No Cracks	-	Slight Indentation
2	-	No Cracks	-	No Damage
3	-	No Cracks	-	Slight Indentation

Plates 4 - Impact Test - System Two

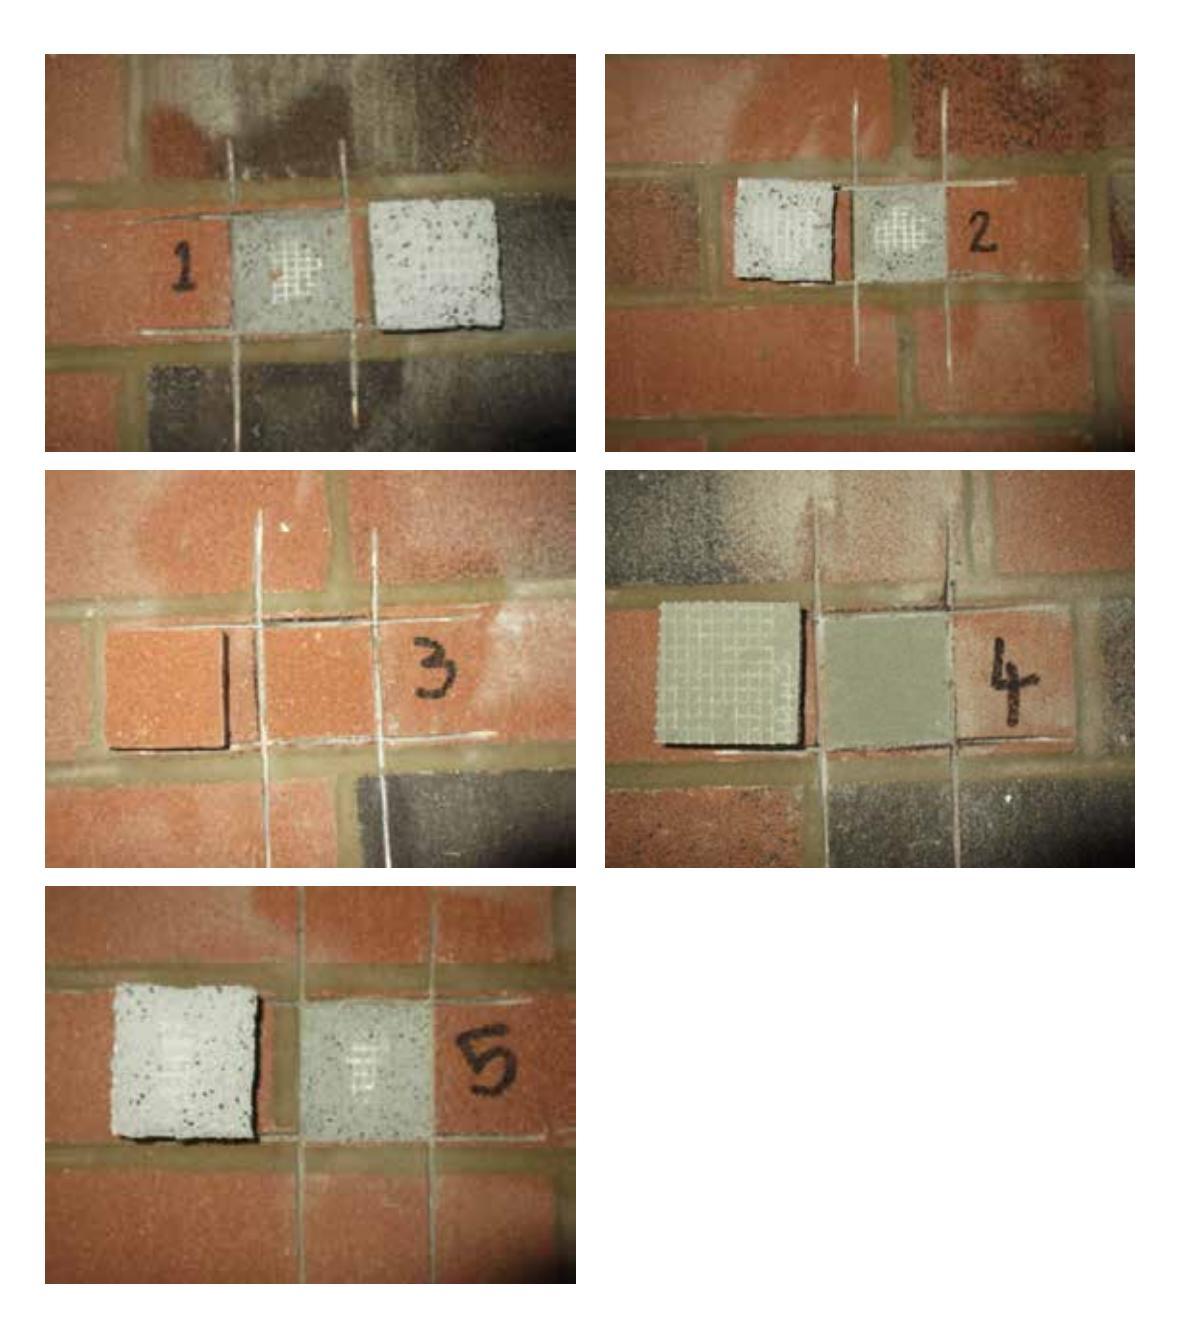
Location	Pull-Off Strength (N/mm ²)	Mode of Failure
1	0.81	Failure within Cement Board
2	0.65	Failure within Cement Board
3	0.92	Failure within Brickslip
4	0.33	Failure between Adhesive Layer and Cement Board
5	0.47	Failure within Cement Board
Mean	0.64	-

Plates 5 - Bond Strength After Hygrothermal Test – System Two

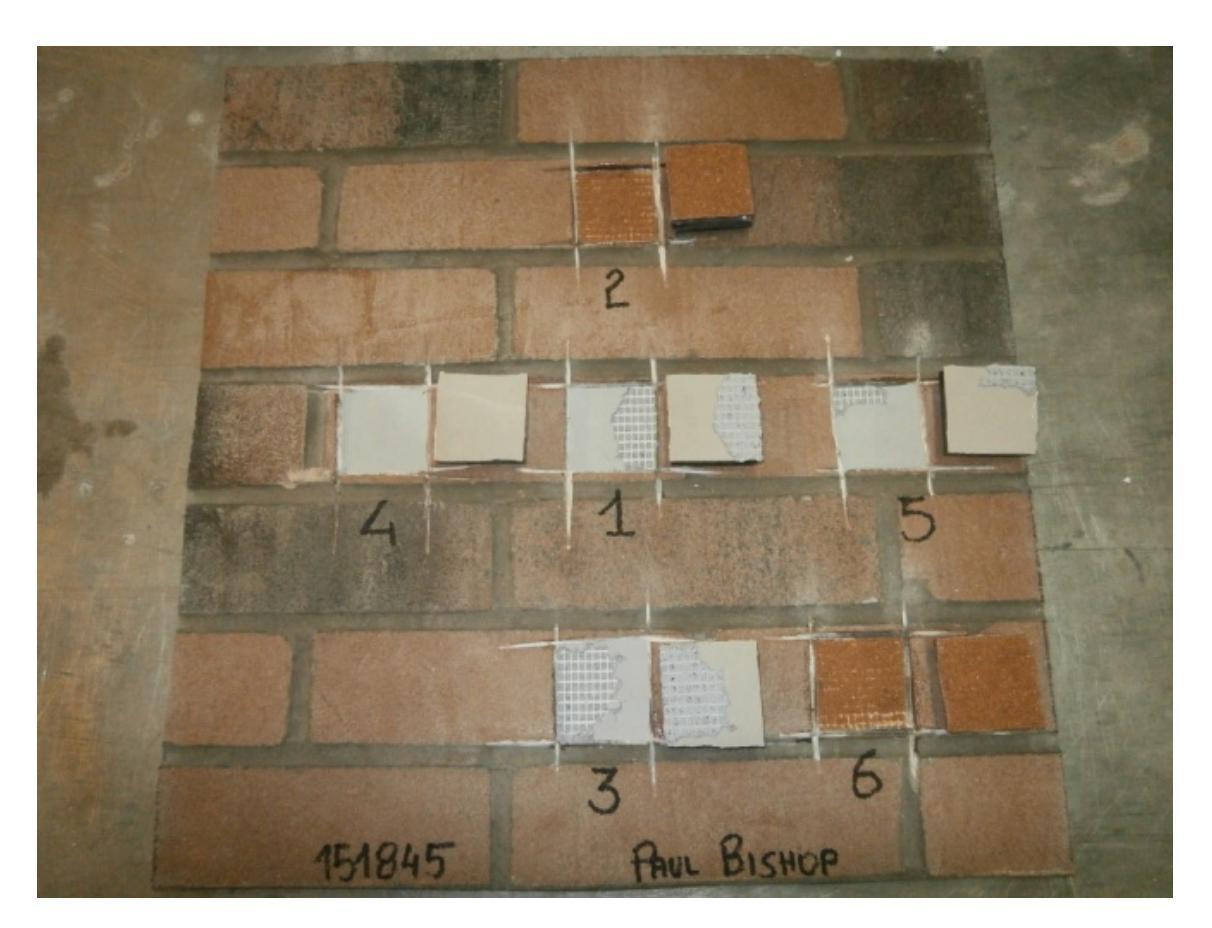
Location	Pull-Off Strength (N/mm ²)	Mode of Failure
1	0.30	Partial failure between Adhesive Layer and Cement Board and partial failure within Cement Board.
2	0.32	Failure within Brickslip
3	0.32	Partial failure between Adhesive Layer and Cement Board and partial failure within Cement Board.
4	0.23	Failure between Adhesive Layer and Cement Board
5	0.29	Failure between Adhesive Layer and Cement Board with minimum failure within Cement Board
Mean	0.31	-

Plates 6 - Bond Strength Control - System Two
